INDOOR AIR QUALITY ASSESSMENT

**Norwood Town Hall
566 Washington Street
Norwood, Massachusetts**

Prepared by:
Massachusetts Department of Public Health
Center for Environmental Health
Bureau of Environmental Health Assessment
Emergency Response/Indoor Air Quality Program
April 2004

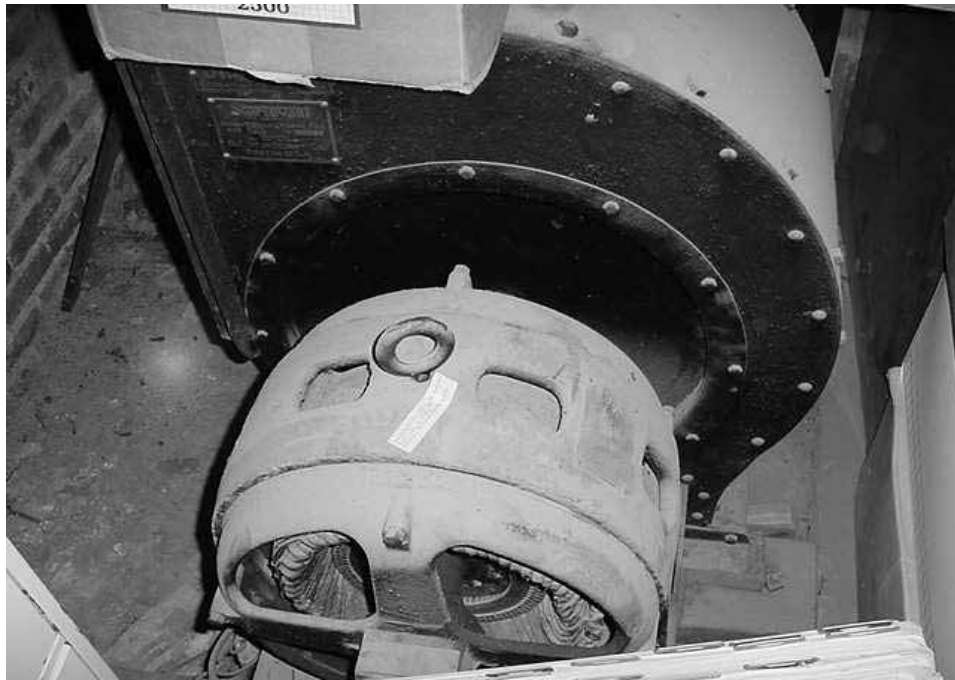
Picture 1

The mechanical ventilation system appears to be the original equipment that was installed during the construction of the NTH. A deactivated fan and motor that serviced the AHU were found in a records storage area of the attic (Picture 1). A variety of open vents that appear to be part of the original ventilation system were found in offices (Pictures 2 and 3). No fresh air intakes or equipment related to the original mechanical ventilation system could be identified on the ground floor.

Deactivated Fan and Motor Found In A Records Storage Area In The Attic

1. Permanently seal openings for the original ventilation system.
2. Replace plastic grates in the suspended ceiling with solid tiles.
3. Continue with plans to replace windows.

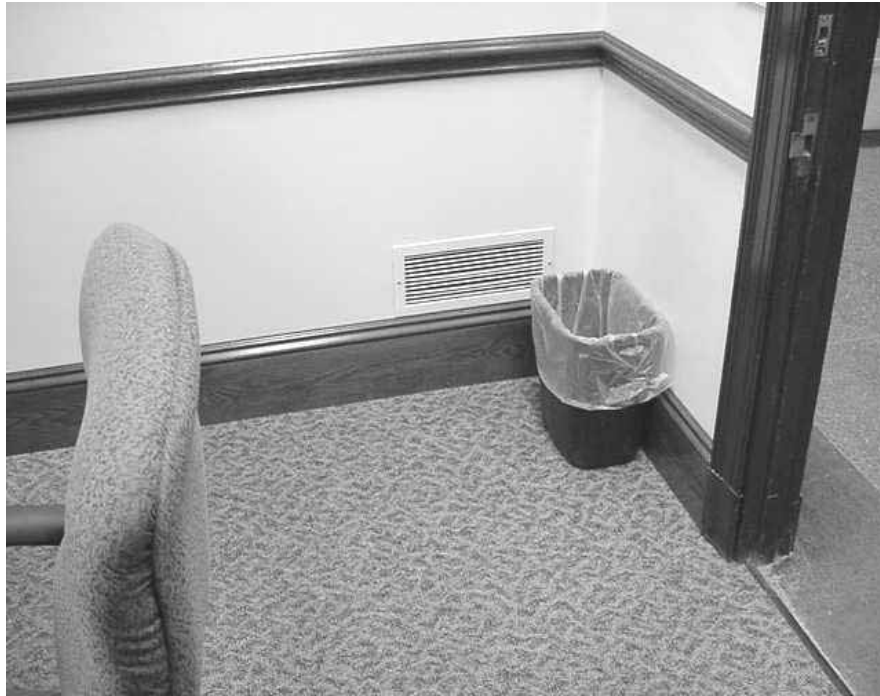
Picture 2

Several other conditions were noted during the assessment, which can adversely affect indoor air quality. Of note was the abandoned ventilation system. Under certain circumstances, the abandoned ductwork can serve as a pathway for odors and particulates to migrate between rooms and floors.

Open Vents Found In Offices That Appear To Be Part Of The Original Ventilation System

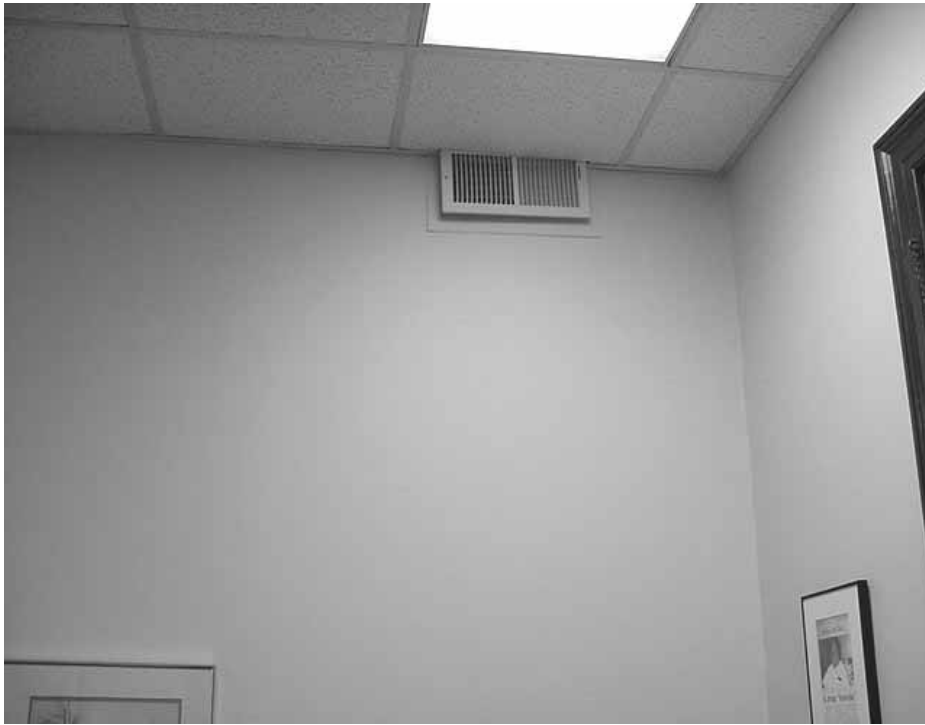
Picture 3

Open Vents Found In Offices That Appear To Be Part Of The Original Ventilation System

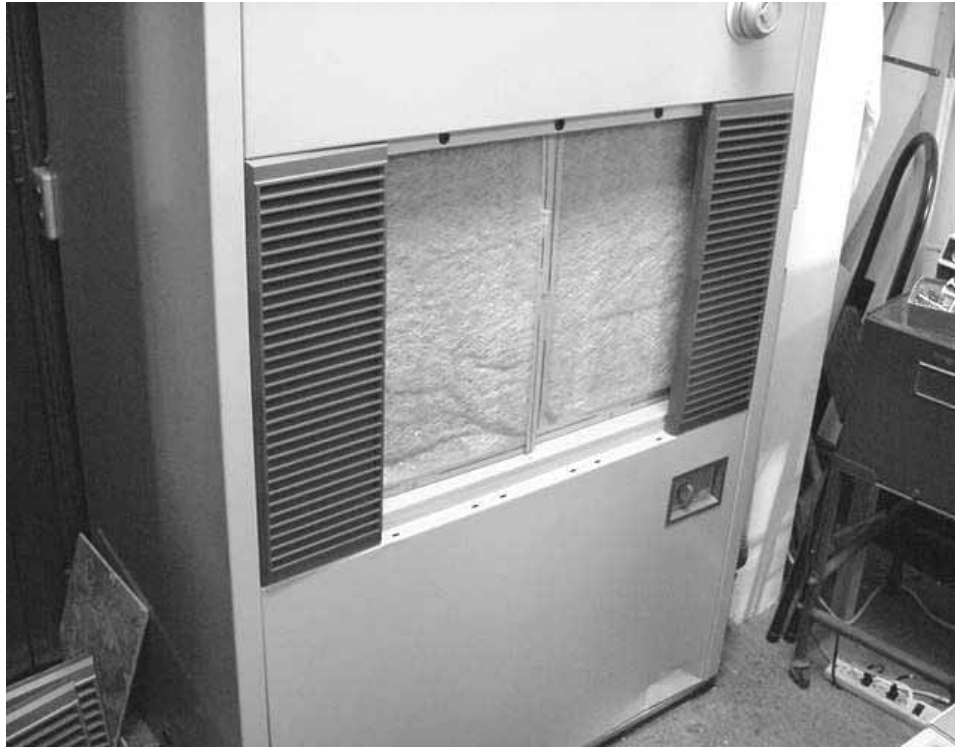
Picture 4

The main offices are serviced by HVAC units located within each office (Picture 4). Ductwork connects the HVAC units to ceiling mounted air diffusers. Neither fresh air intakes nor return ductwork could be identified for this system. Air is returned through a vent that exists in the front of the AHUs. The room is, in essence, a large duct, with air drawn from the farthest point of the office to the AHU through the office space. In an effort to provide some air circulation, a number of ceiling tiles have been replaced with plastic grates. These grates were installed to allow heat to exhaust into the ceiling plenum or to facilitate the draw of air to the AHU. Any normally occurring pollutants that exists in the ceiling plenum or is generated within offices is drawn and concentrated at the return vent of the AHU. In addition, this type of HVAC system design likely also draws air from the open ductwork of the original, abandoned duct system that exists in the building.

Air-conditioning AHUs in a number of areas are installed with air filters that provided minimal filtration of respirable dust and did not fit flush with their racks (Picture 4). Filters should be one piece that fits flush with the filter rack. If two filters are to be used, the filter rack must have the appropriate equipment to make each filter fit flush in the rack. Air drawn into the AHU will bypass filters through spaces between filters and racks. This can result in dust, dirt and other debris being distributed by the ventilation system. In order to decrease aerosolized particulates, disposable filters with an increased dust spot efficiency can be installed in the AHUs. The dust spot efficiency is the ability of a filter to remove particulates of a certain diameter from air passing through the filter. Filters that have been determined by ASHRAE to meet its standard for a dust spot efficiency of a minimum of 40 percent would be sufficient to reduce airborne particulates (Thornburg, 2000; MEHRC, 1997; ASHRAE, 1992). Note, increased resistance from increased filtration can reduce airflow. Prior to any increase of filtration, a ventilation engineer should evaluate each AHU to ascertain whether the unit can maintain function with more efficient filter.

Air Conditioning Air Handling Unit, Note Two Filters

7. Consider installing one-piece air filters in air conditioning AHUs with improve dust spot efficiency. Note that increased filtration can reduce airflow produced by the AHU by increased resistance. Prior to any increase of filtration, each AHU should be evaluated by a ventilation engineer as to whether the heat AHU can maintain function with more filters that are efficient.

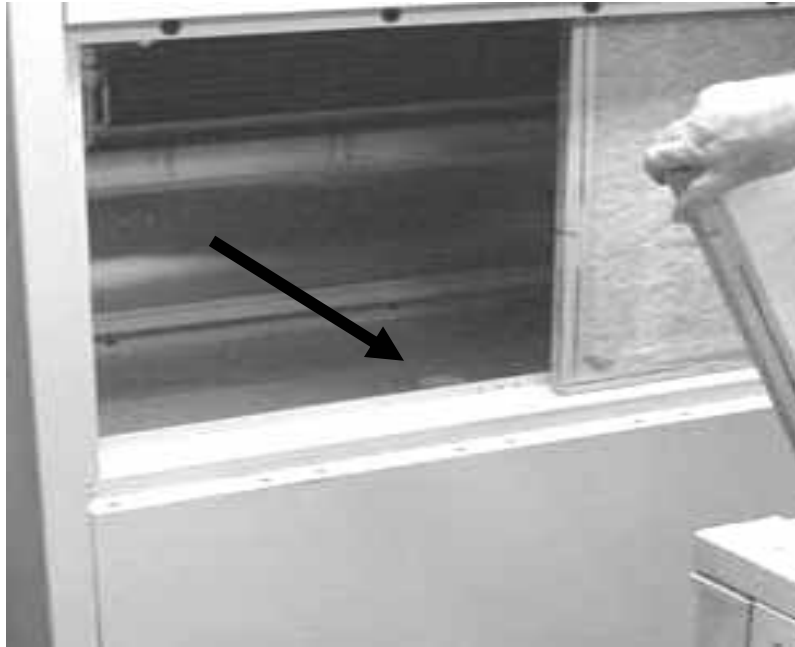
Picture 5

Another potential source of odors within the NTH is the configuration of the air conditioning AHUs. Each AHU is equipped with a drain that removes condensation from the AHU cabinet generated by cooling coils during air conditioning (Picture 5). This drain is connected to a pipe system that contains a trap. The trap, or u-bend, fills with water, which creates a seal that prevents the draw of particles and odors from the drain system by the fans of the AHU. The trap dries out during the heating season and does not fill with water until the AHU is activated for cool air-conditioning,. As a result, the AHU fans can draw air from the

drains. During the initial start up, air from the drain system can be captured by the AHU fans and distributed into occupied areas.

Condensation Drain In Air Conditioning AHU

4. Prior to start up of air-conditioning AHUs, pour a full glass of water into each unit's condensation drain to fill the trap.
5. Temporarily store water-damaged or musty vault records and documents inside plastic storage containers with a sealable lid. A decision should be made concerning the storage of mold contaminated legal books/documents. Porous materials can continue to be a source of mold-associated particulates. In this case, dehumidification and ventilation alone cannot serve to reduce or eliminate mold growth in these materials. As an initial step, options concerning the preservation of materials stored in this area should be considered. Since many historical records appear to be stored, an evaluation concerning disposition of these

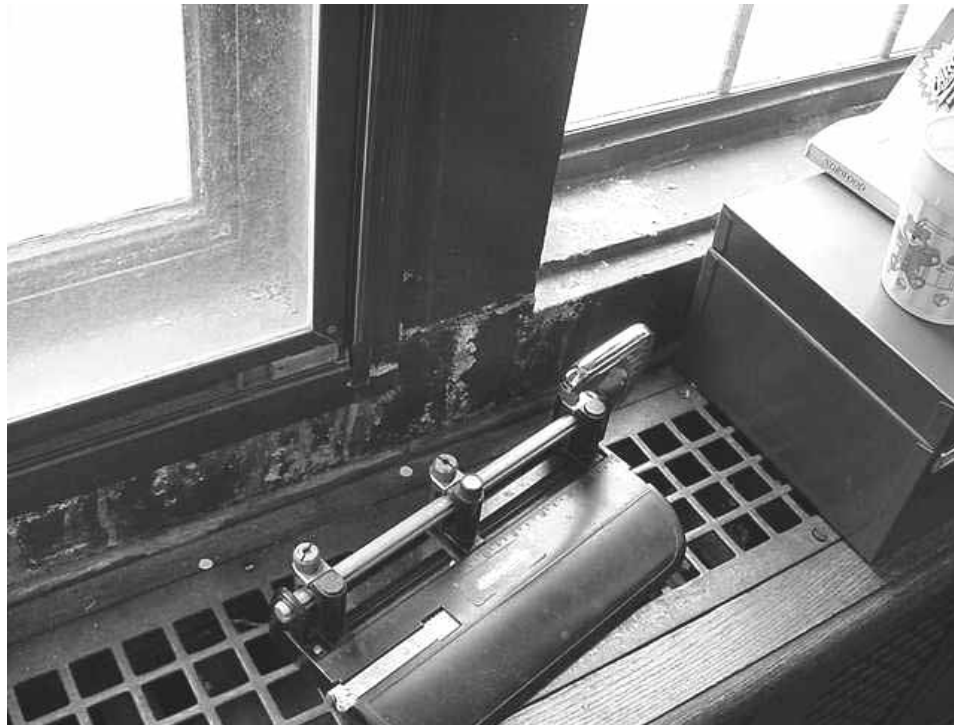
Picture 6

Efflorescence was present under windows in some offices (Picture 6). Efflorescence is a characteristic sign of water damage to brick and mortar, but it is not mold growth. As moisture penetrates and works its way through mortar around brick, water-soluble compounds in bricks and mortar dissolve, creating a solution. As the solution moves to the surface of the brick or mortar, the water evaporates, leaving behind white, powdery mineral deposits. The areas with efflorescence appeared to be historic, rather than active and were in walls made from plaster, which is generally resistant to mold growth. Repointing of the exterior walls and the planned replacement of windows will prevent further water intrusion.

Efflorescence Was Present Under Windows In Some Offices

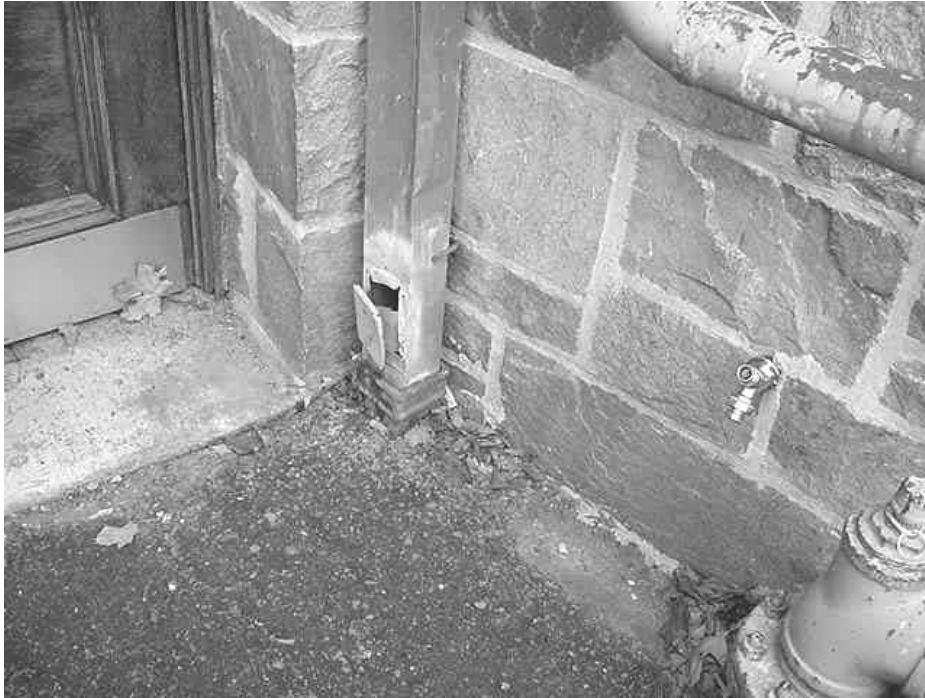
Picture 7

- Damaged downspout located on the front of the building (Picture 7).
- Shrubbery along the front of the building in direct contact with the exterior wall brick (Picture 8). Shrubbery can serve as a possible source of water impingement on the exterior curtain wall due to the location of plants growing directly against the building. Plants retain water and in some cases can work their way into mortar and brickwork causing cracks and fissures, which may subsequently lead to water penetration and possible mold growth.

Each of these conditions allows for the accumulation of water along the base of the building, which can lead to moisture penetration into the basement.

Damaged Downspout

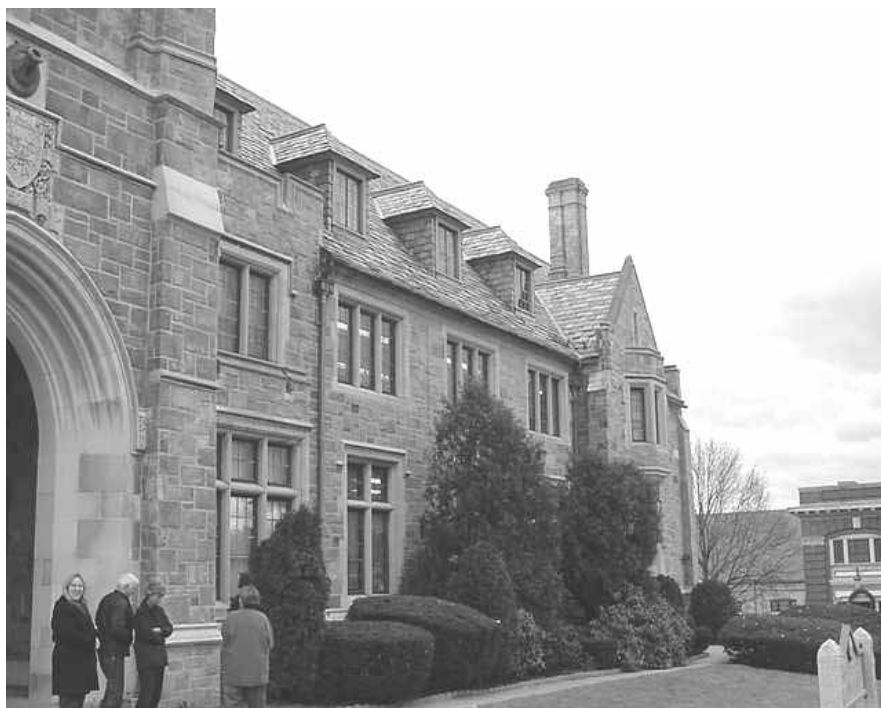
Picture 8

Shrubby In Direct Contact With The Exterior Wall

- a. Remove foliage to no less than five feet from the foundation.
 - b. Improve the grading of the ground away from the foundation at a rate of 6 inches per every 10 feet (Lstiburek, J. & Brennan, T.; 2001).

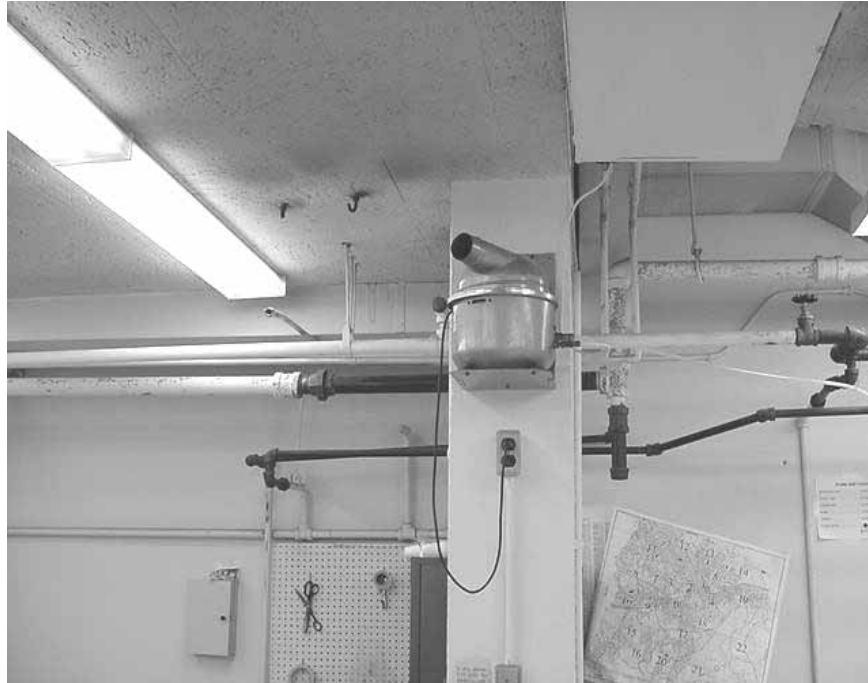
Picture 9

An old humidifier was found in the Engineers' Office (Picture 9). Humidifiers should be cleaned regularly and be maintained as per the manufacturer's instructions to avoid bacterial/microbial growth (EPA, 1991). Care should also be taken in the placement of humidifiers to avoid the repeated saturation of porous material(s), which may also lead to mold growth.

An Old Humidifier Was Found In The Engineers Office

12. Discontinue the use of the humidifier in the engineers office.
13. Refer to the resource manual and other related indoor air quality documents for further building-wide evaluations and advice on maintaining public buildings.
